## Building Design Guide

# The Needles Old Battery

Installation of modern heating technology

The Needles Old Battery, Isle of Wight

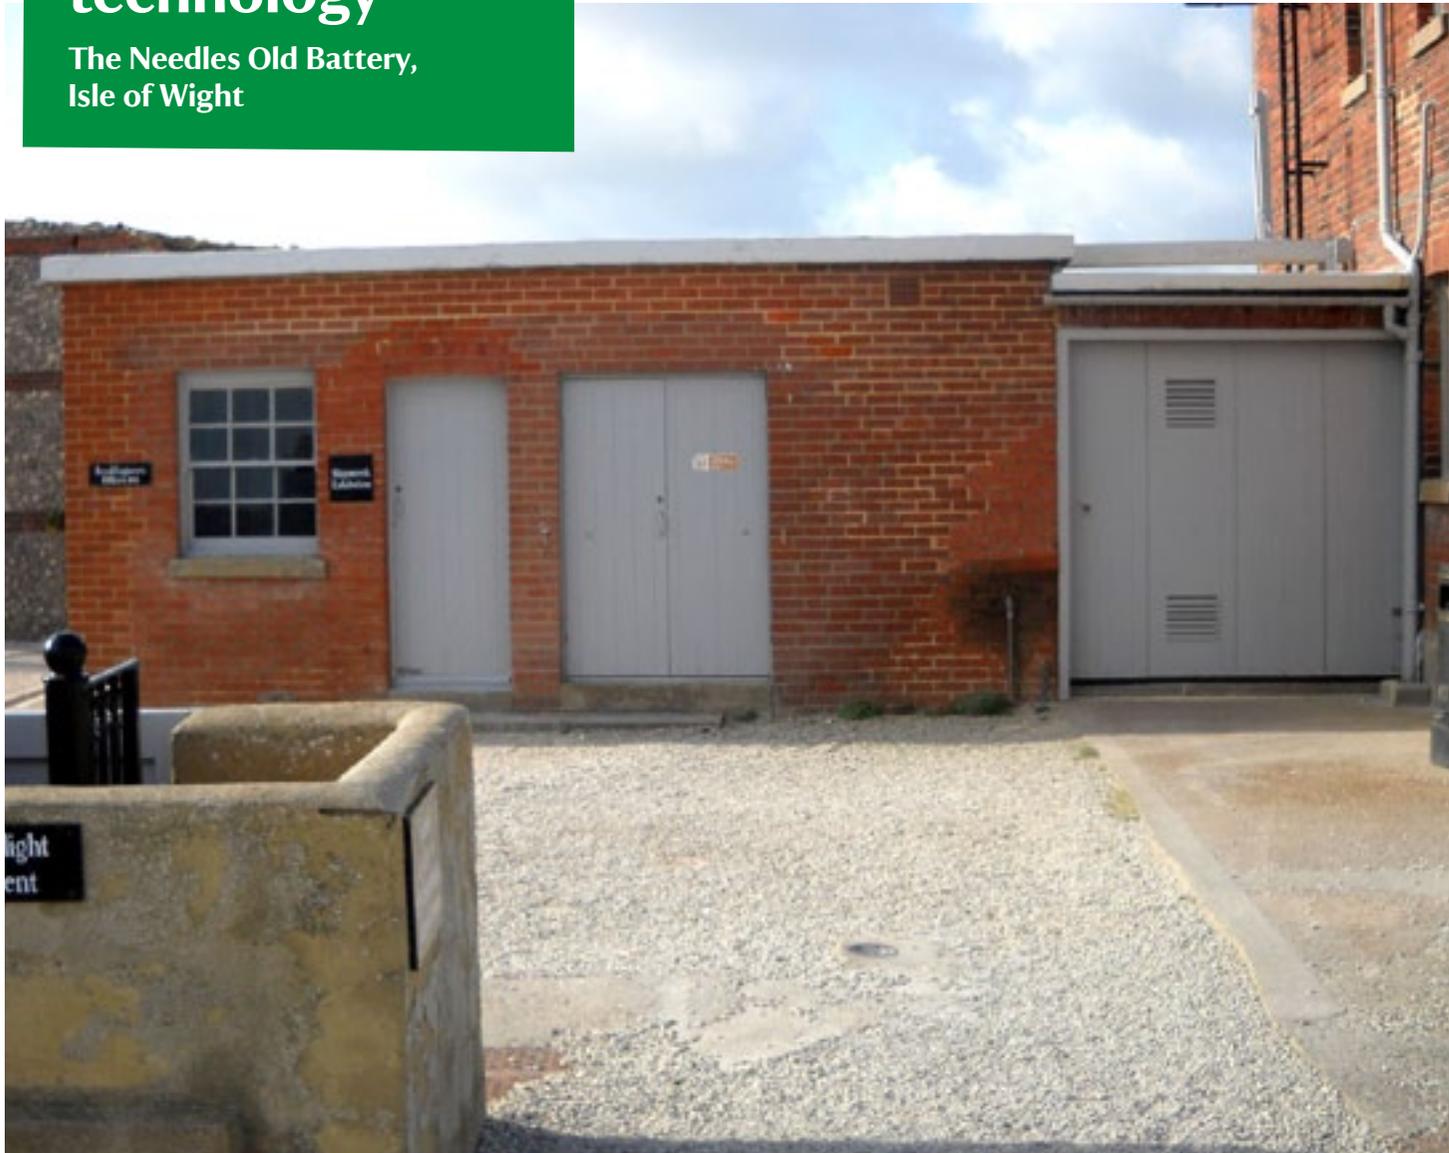
**Left The Plant room where the oil storage tank was originally housed, showing oil staining and evidence of many alterations to the original brickwork and openings prior to the project beginning**

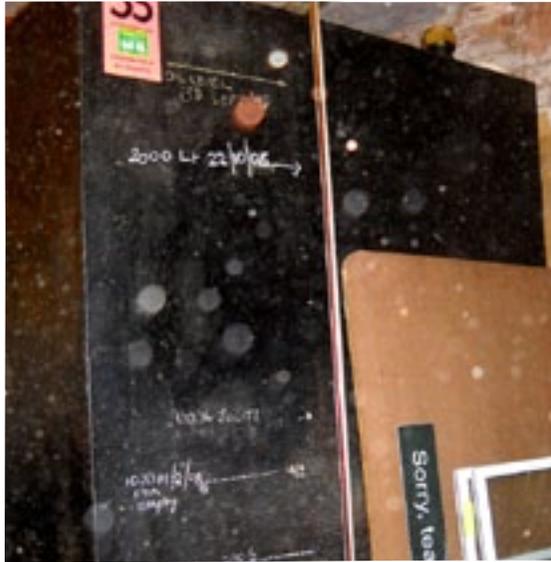
Left **The original oil-fired boiler**

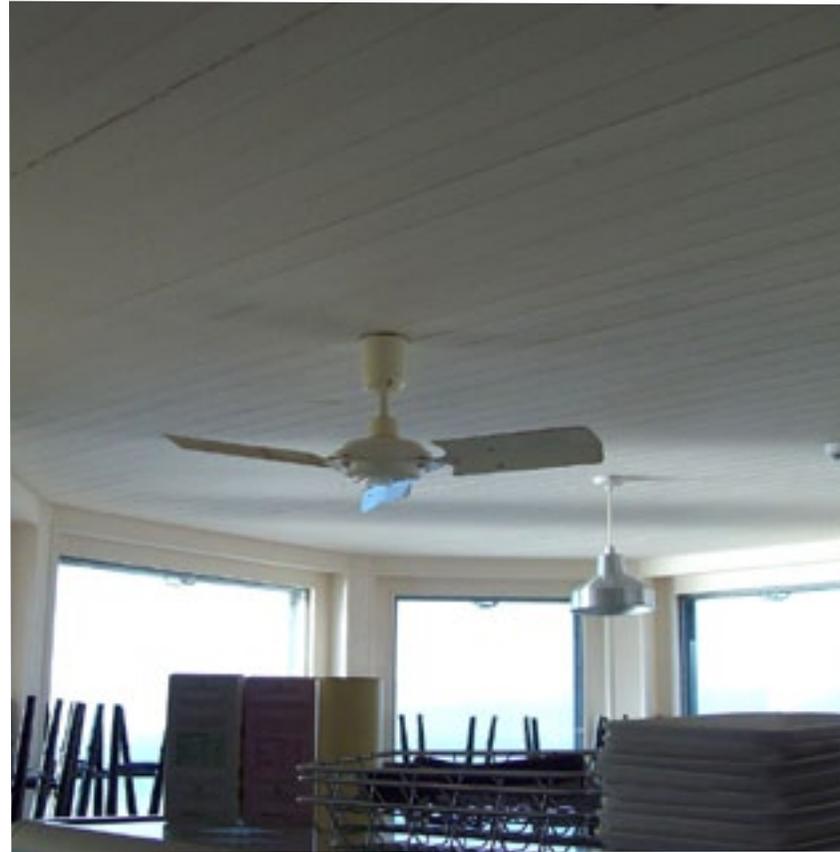
**Top right Original Matchboard ceilings in the tearoom**

The roof insulation had to be installed internally due to the concrete flat roof; however alterations to the ceiling heights were also restricted due to the position of the windows. The original tongue and groove Matchboard ceiling in the main tearoom was carefully removed and reinstated with insulation restricted to the depth of the ceiling joists. The landing, kitchen, and servery had original smooth rendered ceilings with surface mounted electrics, so new false ceilings were added just above full window height to allow the maximum possible insulation depth. A new tongue and groove Matchboard finish was chosen in keeping with the main tearoom fixed to new softwood ceiling joists, and the existing electrical fittings were wired to the new lower level.

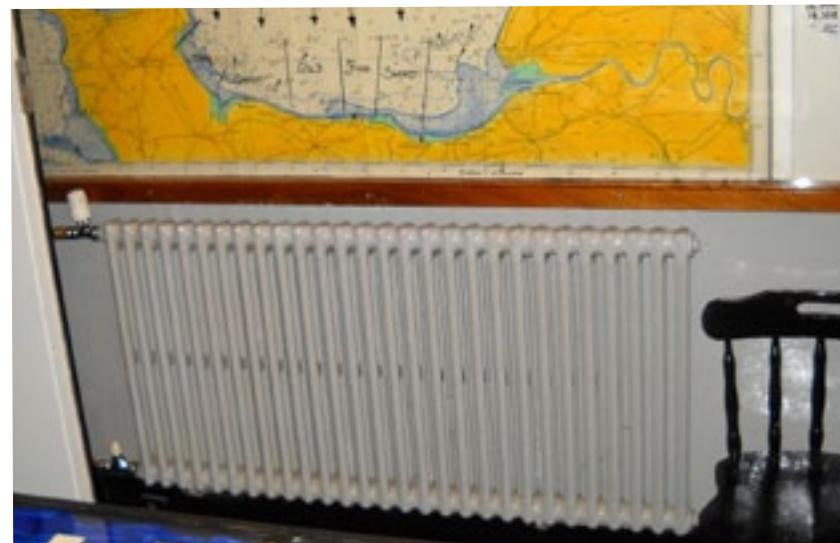
**Bottom right Existing cast iron radiator**

The building had a mixture of original cast iron radiators and newer modern additions in various styles. The existing cast iron radiators were retained where possible, but one undersized radiator was replaced with a new cast iron column radiator. It was decided to install modern twin panel 'Booster' radiators in a previously unheated area and to replace the two existing modern radiators in the main tearoom. The new system followed the old layout as much as possible to minimise the impact on the building fabric. The new pipes and radiators were chosen to complement but not replicate the existing thereby maintaining the aesthetic; this was helped by painting the radiators to match the existing tearoom decoration. All of the radiators are fitted with thermostatic valves.

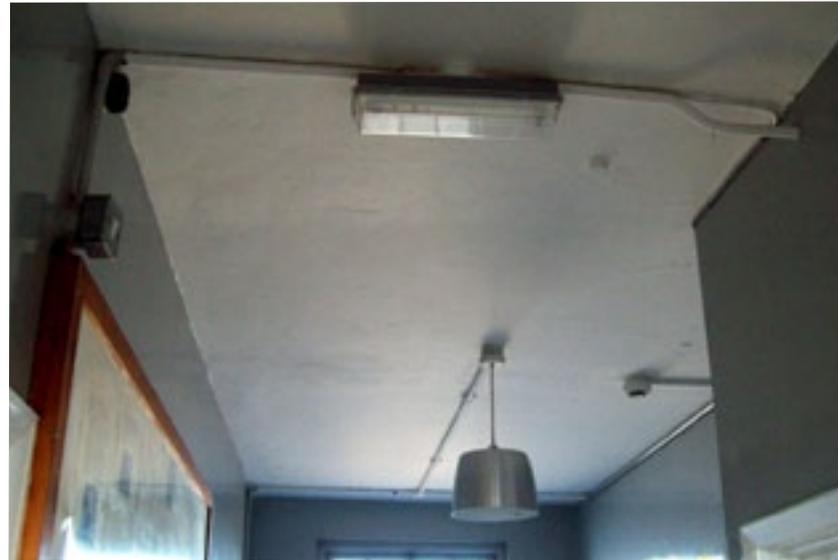
Top right **The existing smooth rendered ceiling, showing the surface mounted electrics and the height of windows which required the installation of a false ceiling for insulation**

A single layer of 100mm Celotex dense foam insulation was used between the ceiling joists with a layer of Triso Super 10 multifoil insulation crossing under the joists as a vapour barrier to enable the lowest possible u-value in a restricted space. The electricians had to be adapted to compensate for the new false ceiling heights with the wiring set above the insulation to avoid wires from overheating.

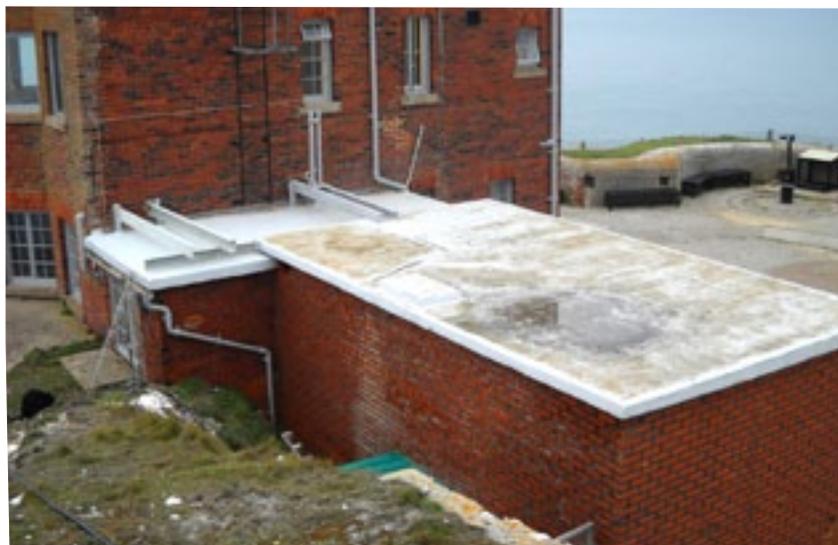
Bottom right **The Plant room's concrete flat roof, the proposed site for Photovoltaic panels**

The plan is to install photovoltaics on the flat roof of the Plant room which will contribute to the building's overall electricity usage. Suitable space for the photovoltaics is restricted due to the sensitive nature of the site thus they will only be able to produce a small percentage of the ASHP's requirements – 2.1kW in the best light, as opposed to the 16kW ASHP requirement. They are to be viewed as a demonstrable technology in a popular visitor spot designed to engage with visitors.

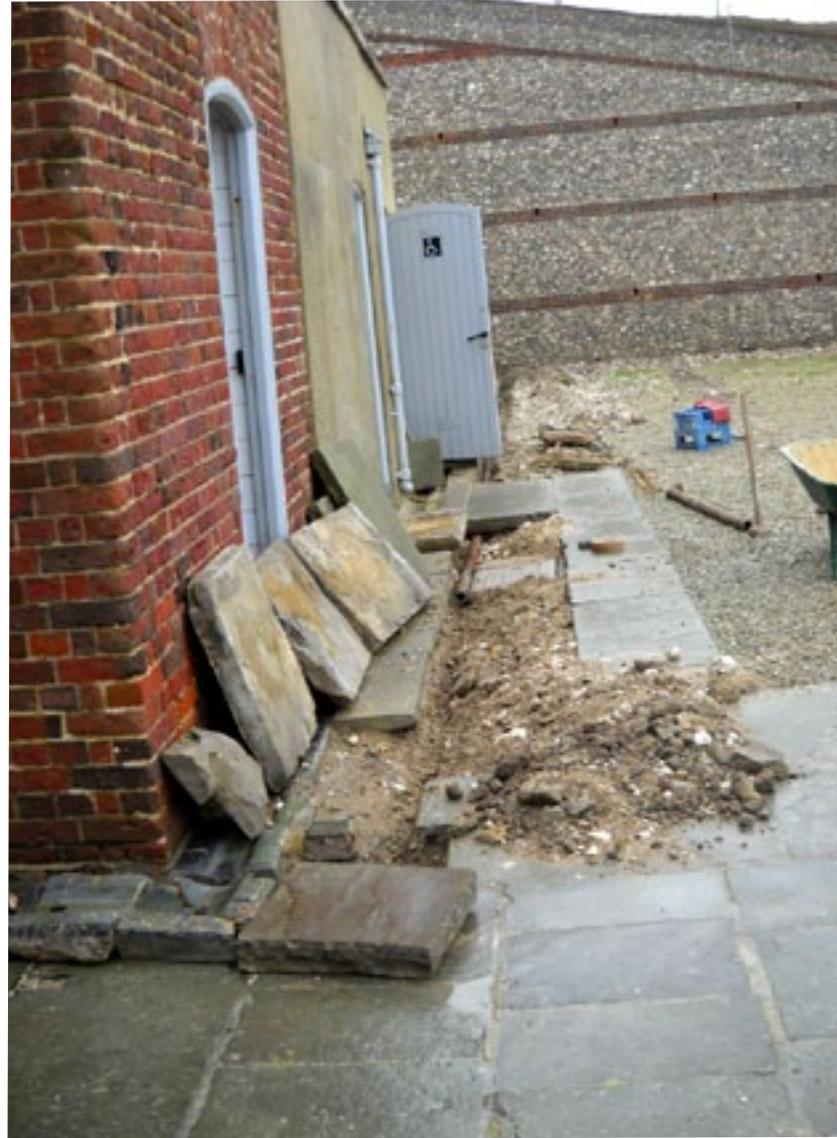
Above Oil pipe ready to be removed from under flagstones by the pulley system

The external oil pipe system ran underground skirting the perimeter of the Parade Ground. The oil pipe removals were carried out over a couple of weeks during December 2009 and timed to enable weekend opening to visitors. The pipes had a static pressure test to ensure that they were sound before being flushed through with water prior to removal; this prevented any contamination of the ground. One pipe length ran under flagstones; one of these was too heavy to move without undue cost so the specialist removed it hydraulically. All other pipes were dug out by hand to prevent damage to the nearby footing remains of original structures. The flagstones were re-laid in their original positions.

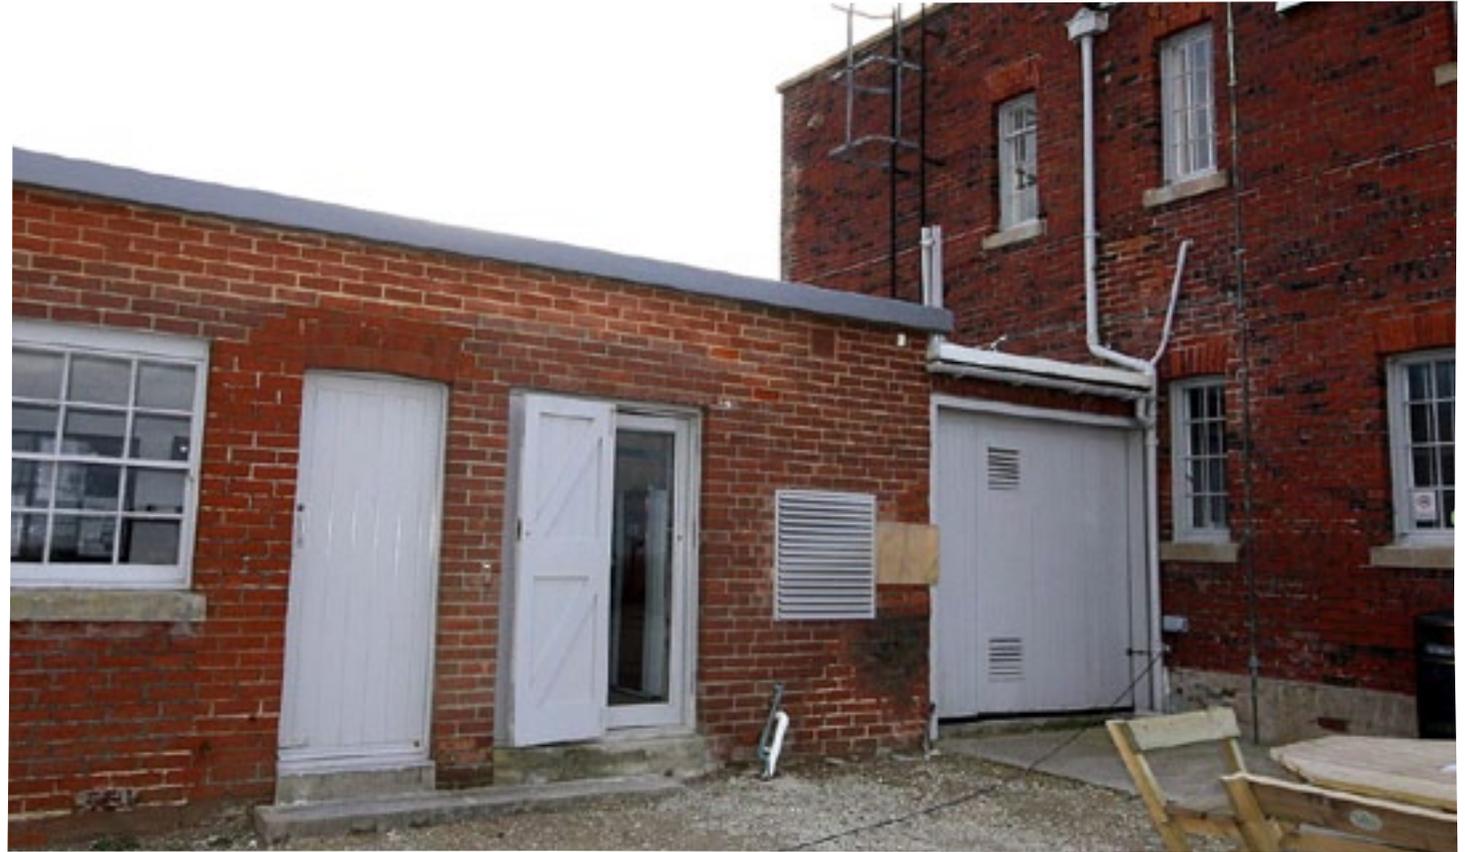
Top right **The finished exterior of the Plant room showing the new ASHP discharge louvre and sliding glass door installed for public viewing**

Interpretation boards were provided to explain the ASHP; however visitors expressed further interest in seeing inside the Plant room. The external doors were accordingly adapted and a glass sliding door positioned to allow safe public viewing.

The ASHP was installed and mounted internally to avoid damage from weather exposure and windblown chalk dust from the surrounding site. The pump absorbs heat from the outside air and so had to be fitted with both an intake and discharge louver to the outside. This involved making two holes in the Plant room external walls positioned where plenty of fresh air would circulate around the inlet louver. The louvers were positioned on opposite walls creating a cross flow through the building from back to front. The intake louver was positioned on the south facing wall to exploit maximum heat gains.

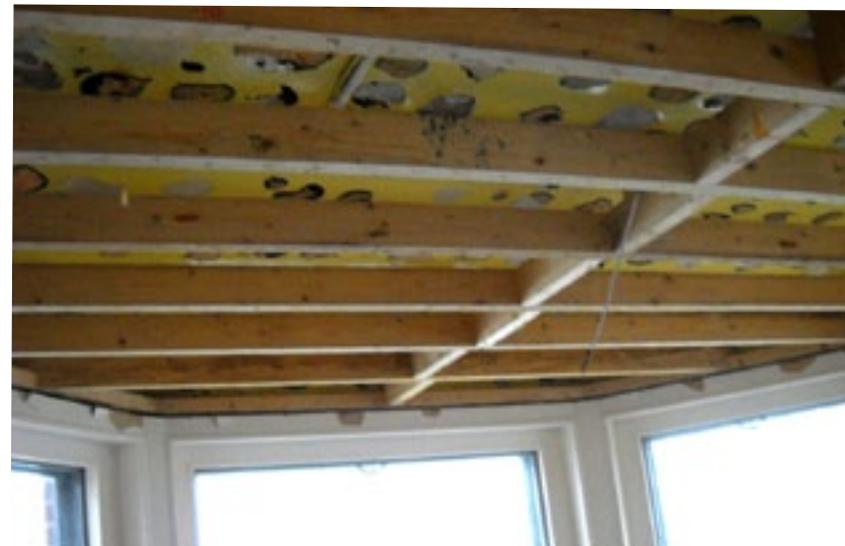
Bottom right **Exposed rafters after Matchboard ceiling removed**

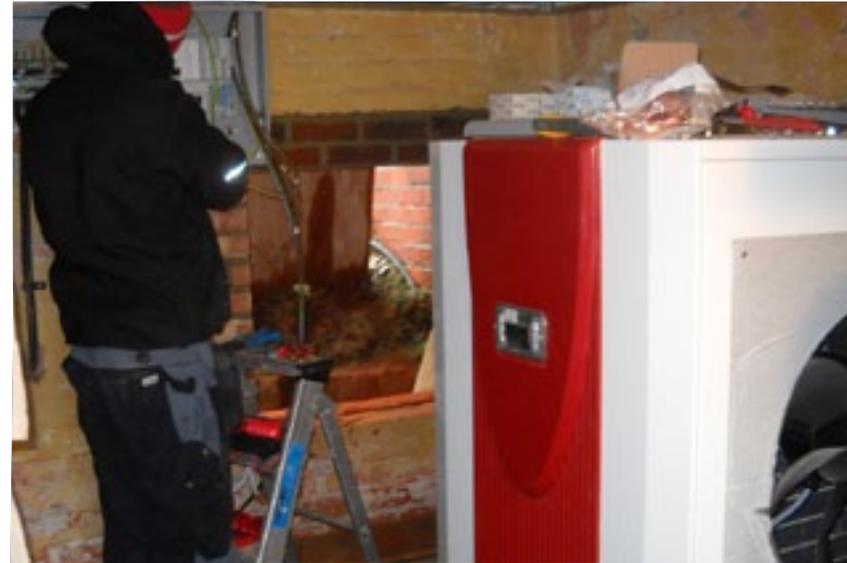
Above ASHP  
installation in progress  
with inlet opening  
created in cavity wall

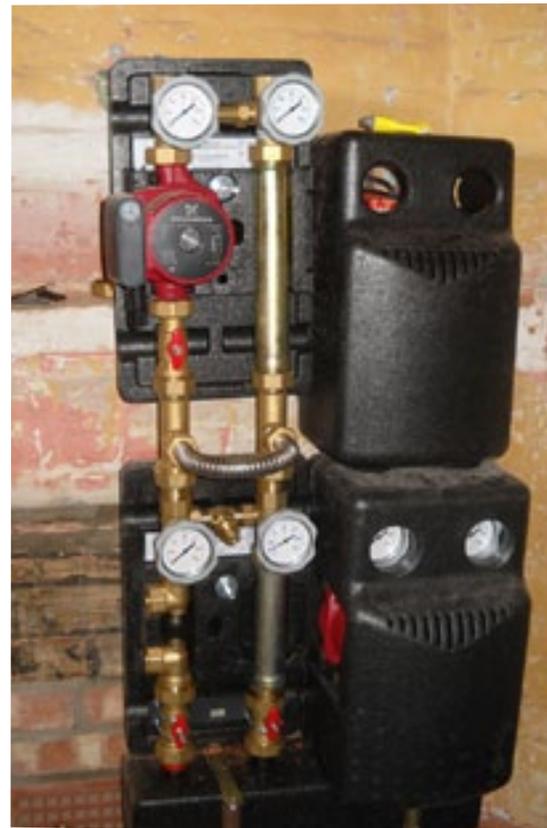
Left New ASHP controls

■ The contractors remained on site to conduct other works post project. This has allowed fine tuning adjustments to be made to the ASHP controls, therefore tailoring the system to the user's specific needs. The system has been made more efficient by reducing hot water temperatures and fuel consumption, and staff have had time to familiarise themselves with the controls so that they can make the adjustments themselves in the future.

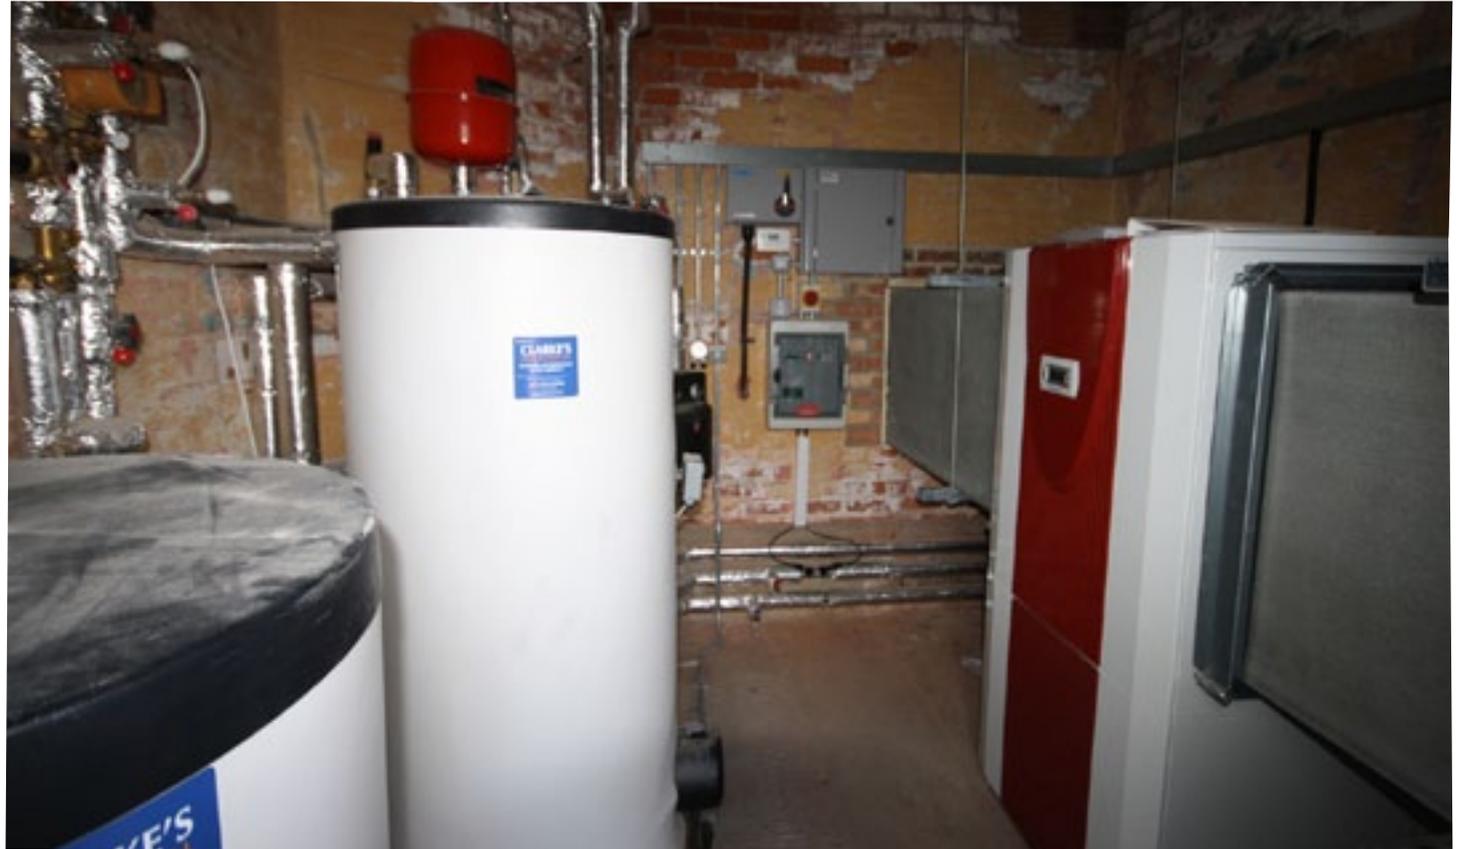
Above **Plant room interior with the oil tank removed, new hot water storage tanks, ASHP and controls**

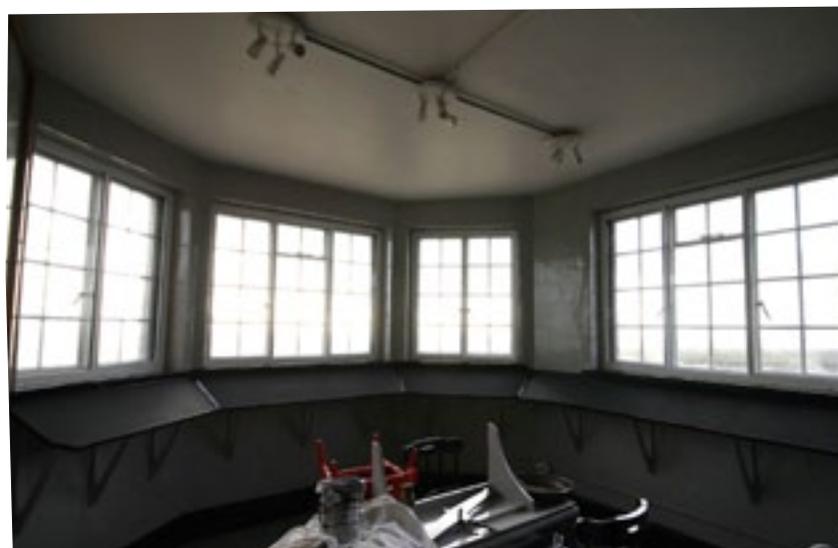
Left **Panoramic windows with secondary glazing**

■ Choosing to improve the thermal performance of the building as well as renewing the heating system has proved very successful. The extra booster function on the new 'booster radiators' has so far not been required despite severely cold weather thus proving that the insulation and secondary glazing is working well to retain heat over night.

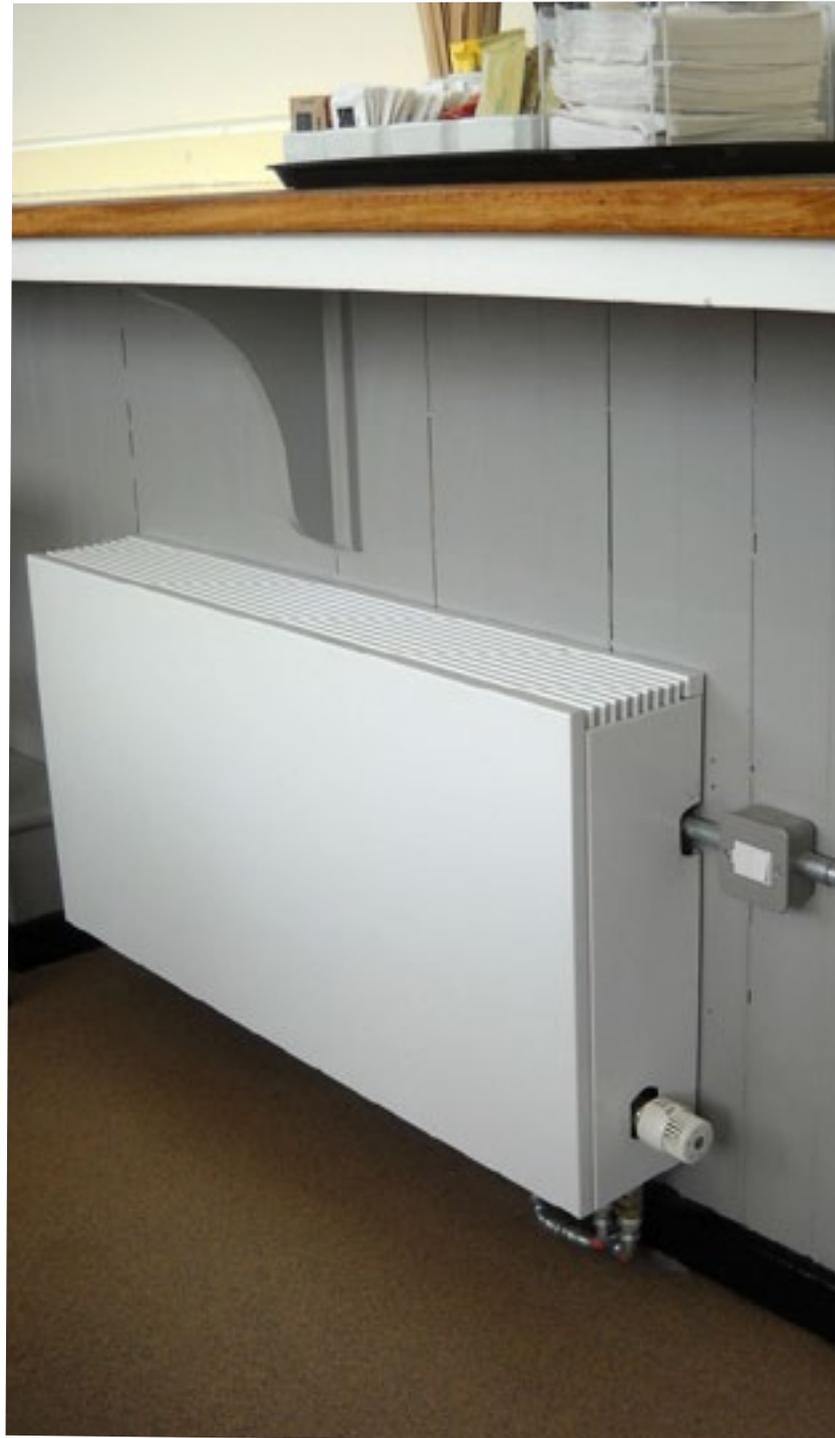
Left **The new Boosted radiator requires an electrical supply to power the booster fan**

Unlike the oil boiler the ASHP delivers the heat at lower temperatures. This means that the radiators are not expected to feel as hot to the touch as they would from an oil boiler (which in a public building has health and safety advantages); however this does mean that the ASHP system works more effectively with underfloor heating or larger radiators which can give out heat at lower temperatures over longer periods of time. Where standard radiators are used it is generally recommended that they are approximately 50% bigger than normal however, here twin panel boosted radiators were added into the system alongside the original cast iron radiators. The boost enables them to operate at low temperature without needing to be oversized.

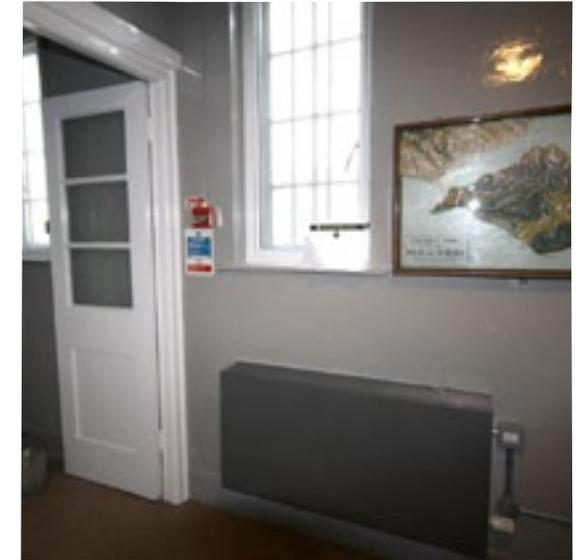
Above **Secondary glazing in the hallway with the Boosted radiator painted in Goosewing Grey**

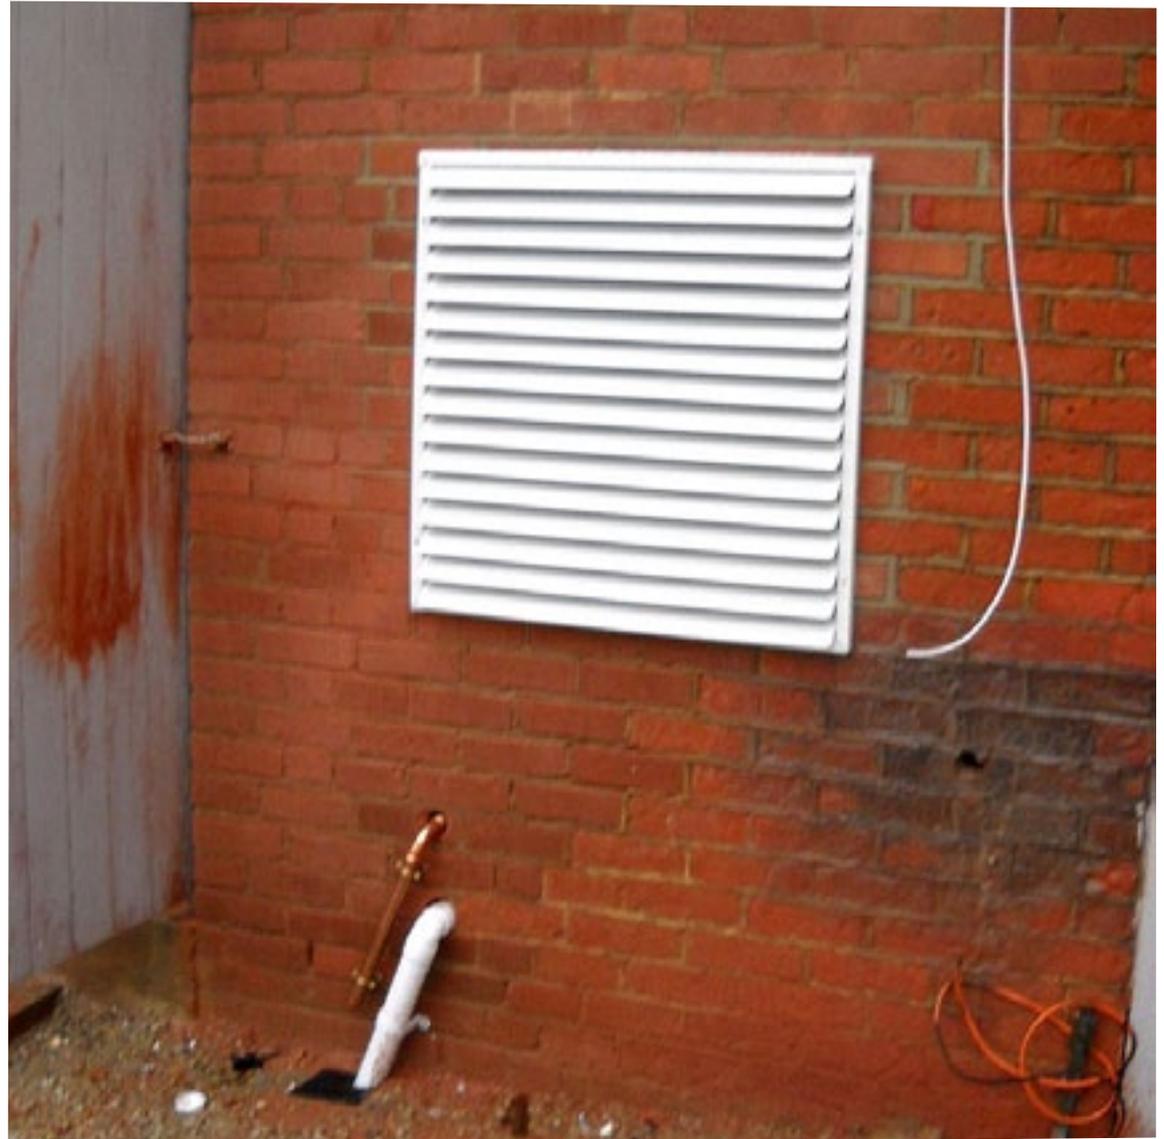
Above ASHP External discharge louvre during construction

The new external louvers were finished off with paint in 'Goosewing Grey' to match existing site colours.
